Project Name:	Mountain Valley Pipeline	Inspector:	Matthew Grant
Inspection Date:	Tuesday, March 2, 2021	Project Contact:	Brian Clauto
Spread G: Craig Giles	ST11620-11600 ATWS 1370, 1370A, 1057, 1373 AR- MRV25, GI 234, GI249.01, 258.01	Weather:	Dry

FIELD INSPECTION PHOTO LOG

<u>Project Name</u>: Mountain Valley Pipeline <u>Date</u>: Tuesday, March 2, 2021

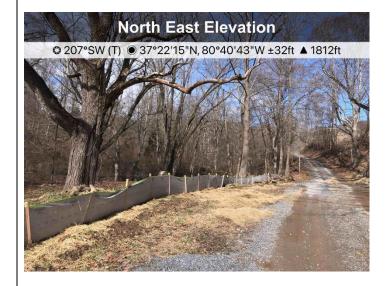
Figure 1: ECD's remain installed on AR-GI 234

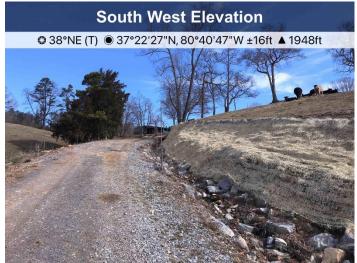
Figure 2: Blanket matted remains installed at AR GI- 234

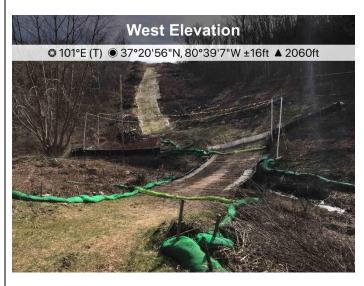
Figure 3: Designated crossing S-G32, ECD's are in place and functioning.

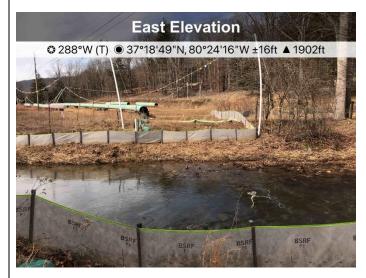
Figure 4: Designated crossing S-006, ECD's are in place and functioning.
